Facility Name: <u>Quintec, Inc.</u>			
Facility Identification Number: <u>IND 000 199 653</u>			
A.1 General Correspondence <u>A.1.1-A.1.7</u>	1	B.2 Permit Docket (B.1.2)	
A.2 Part A / Interim Status <u>A.2</u>	1	.1 Correspondence <u>B.1.1</u>	1
.1 Correspondence	Y	.2 All Other Permitting Documents (Not Part of the ARA) <u>A.1.2(3), B.1.3, B.1.4, B.1.8</u>	5
.2 Notification and Acknowledgment	Y	C.1 Compliance - (Inspection Reports) <u>C.1.1</u>	1
.3 Part A Application and Amendments	Y	C.2 Compliance/Enforcement <u>C.2.2(2)</u>	2
.4 Financial Insurance (Sudden, Non Sudden)		.1 Land Disposal Restriction Notifications	
.5 Change Under Interim Status Requests		.2 Import/Export Notifications <u>C.2.2</u>	1
.6 Annual and Biennial Reports		C.3 FOIA Exemptions - Non-Releasable Documents <u>C.3.2(2)</u>	2
A.3 Groundwater Monitoring		D.1 Corrective Action/Facility Assessment	
.1 Correspondence		.1 RFA Correspondence

**RE: EPA 2009 Multi-media RCRA Inspection Report
Notice of Violation
Quemetco, Inc., Indianapolis, IND 000 199 653**

Attachment A
Inspection Photographs
Quemetco, Inc. (EPA ID No.: IND000199653)
Indianapolis, Indiana
May 18 – 20, 2009

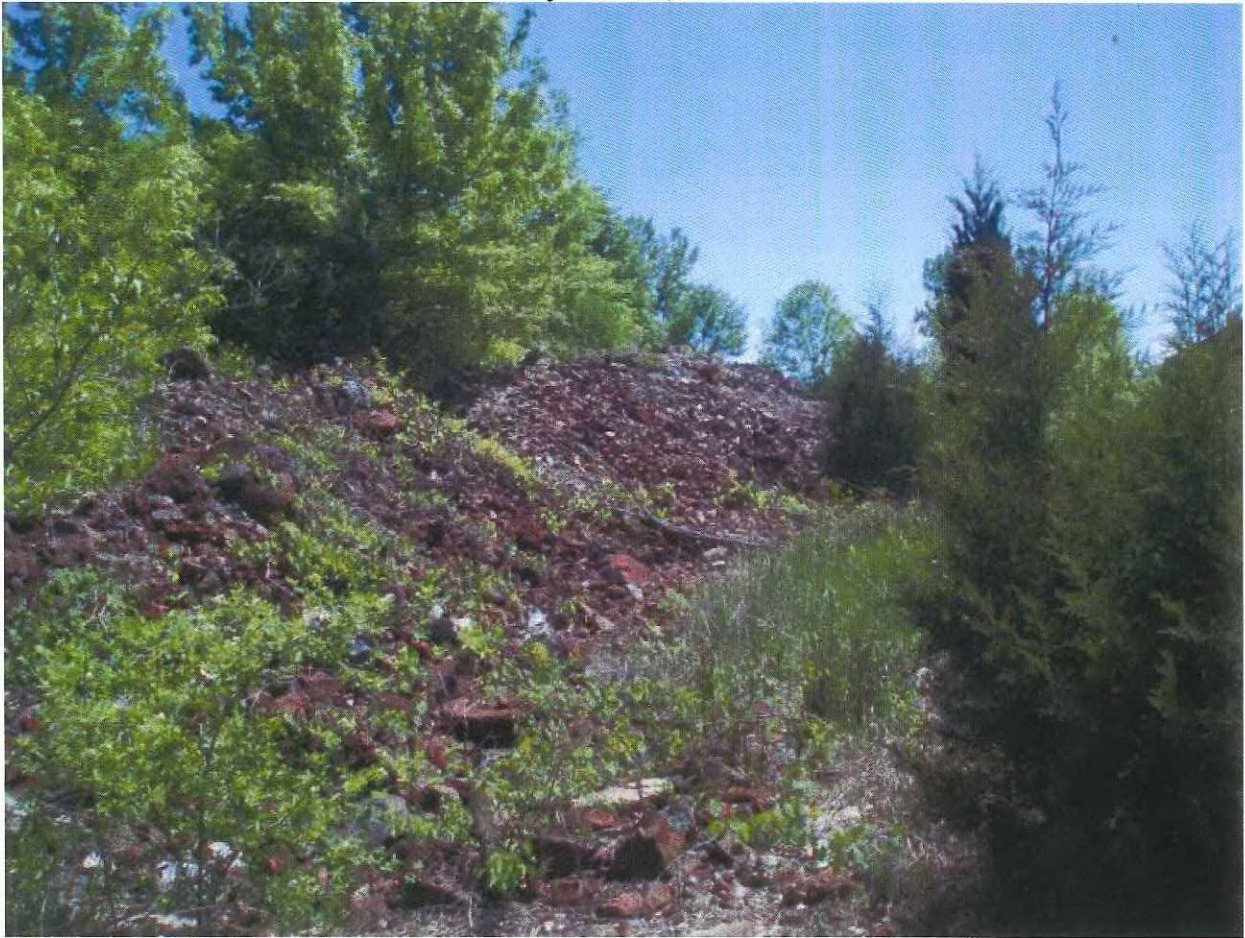
Photograph 1: Slag pile at Quemetco, Inc., Indianapolis, Indiana. The pile is located on the west side of Quemetco's property. The digital photograph was collected on May 18, 2009, at approximately 1:53 P.M., Central Standard Time (CST). The photographer was Todd Brown, U.S. EPA. The filename is P5180001.

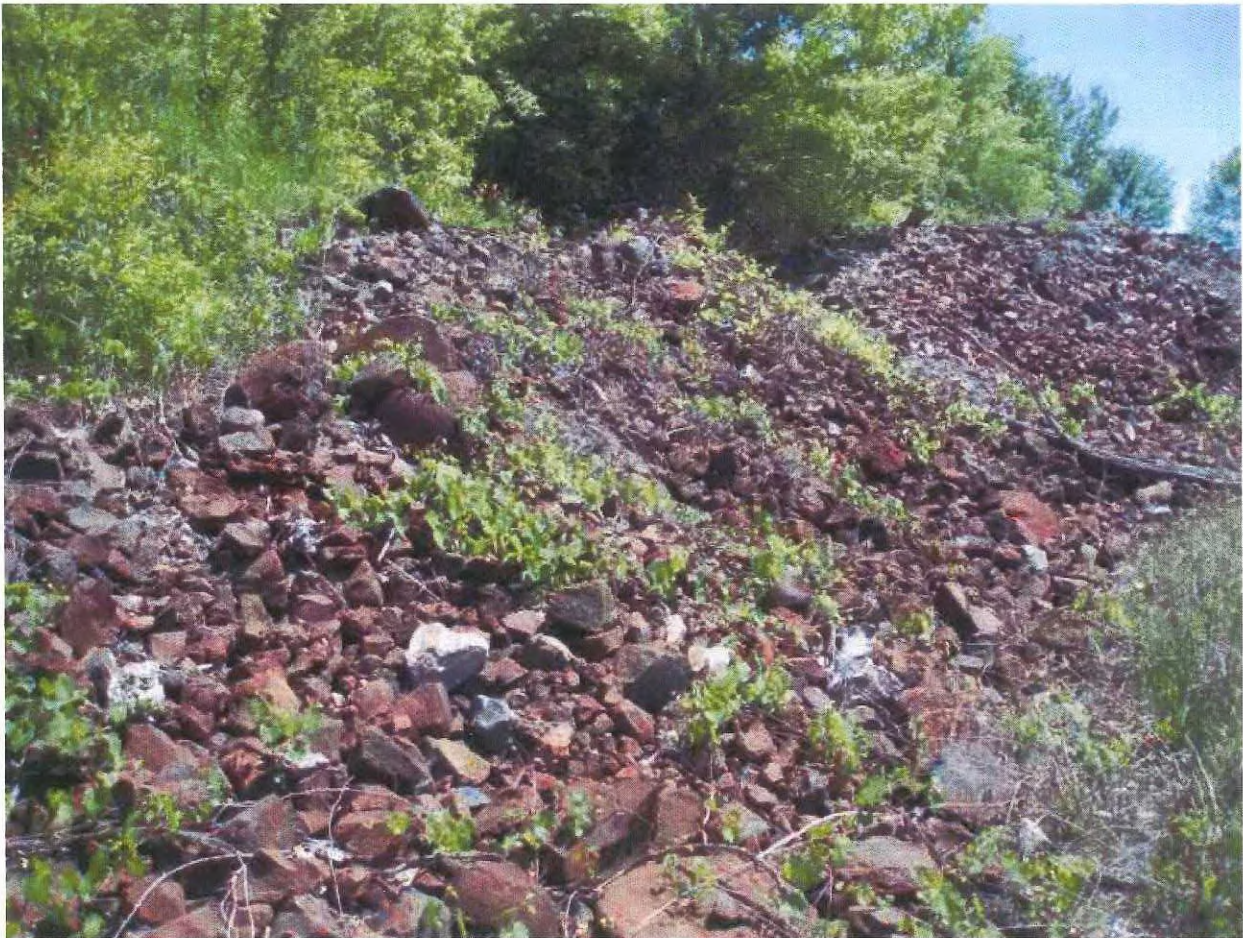
Photograph 2: Slag pile at Quemetco, Inc., Indianapolis, Indiana. The pile is located on the west side of Quemetco's property. The digital photograph was collected on May 18, 2009, at approximately 1:53 P.M. (CST). The photographer was Todd Brown, U.S. EPA. The filename is P5180002.

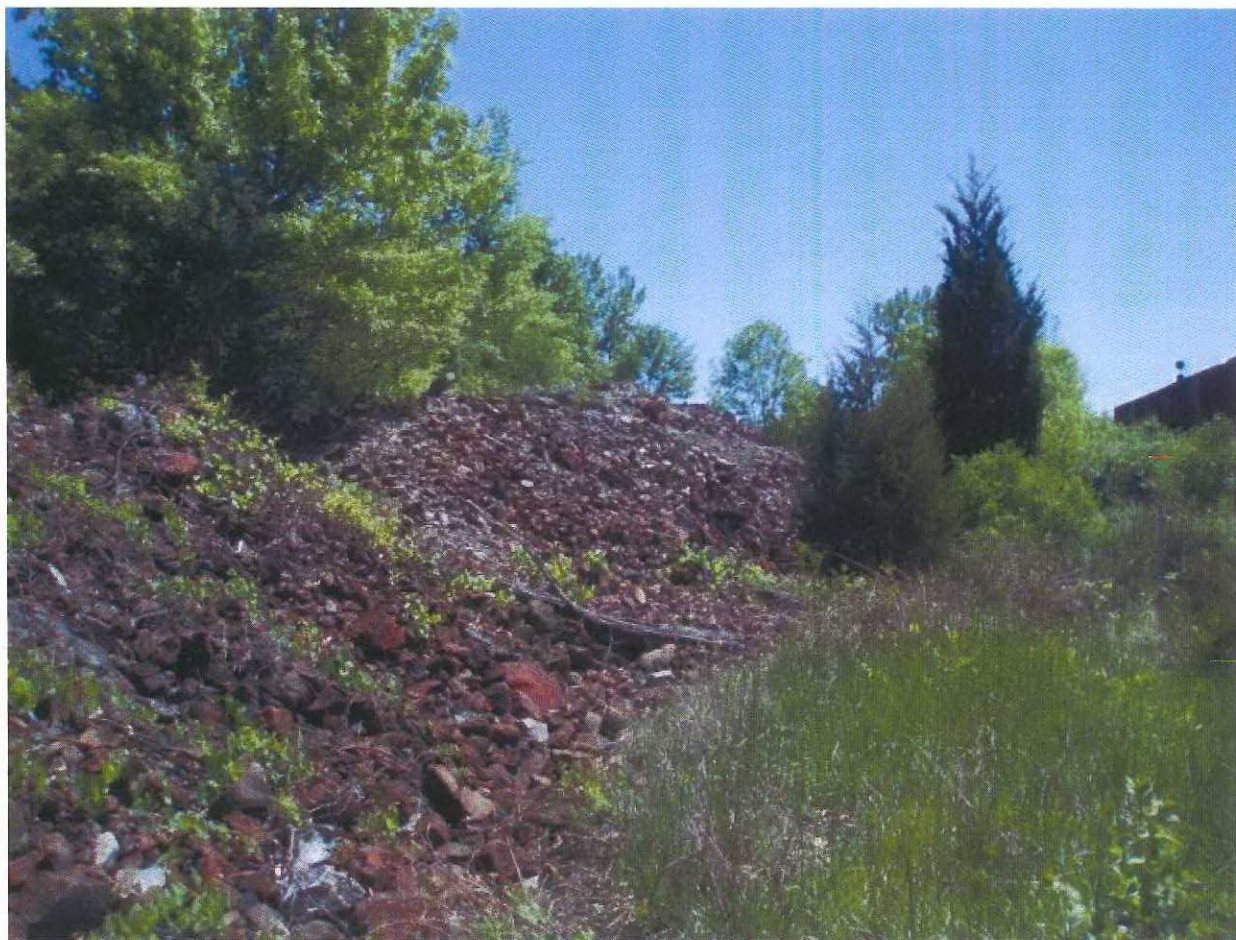
Photograph 3: Slag pile at Quemetco, Inc., Indianapolis, Indiana. The pile is located on the west side of Quemetco's property. The digital photograph was collected on May 18, 2009, at approximately 1:53 P.M. (CST). The photographer was Todd Brown, U.S. EPA. The filename is P5180003.

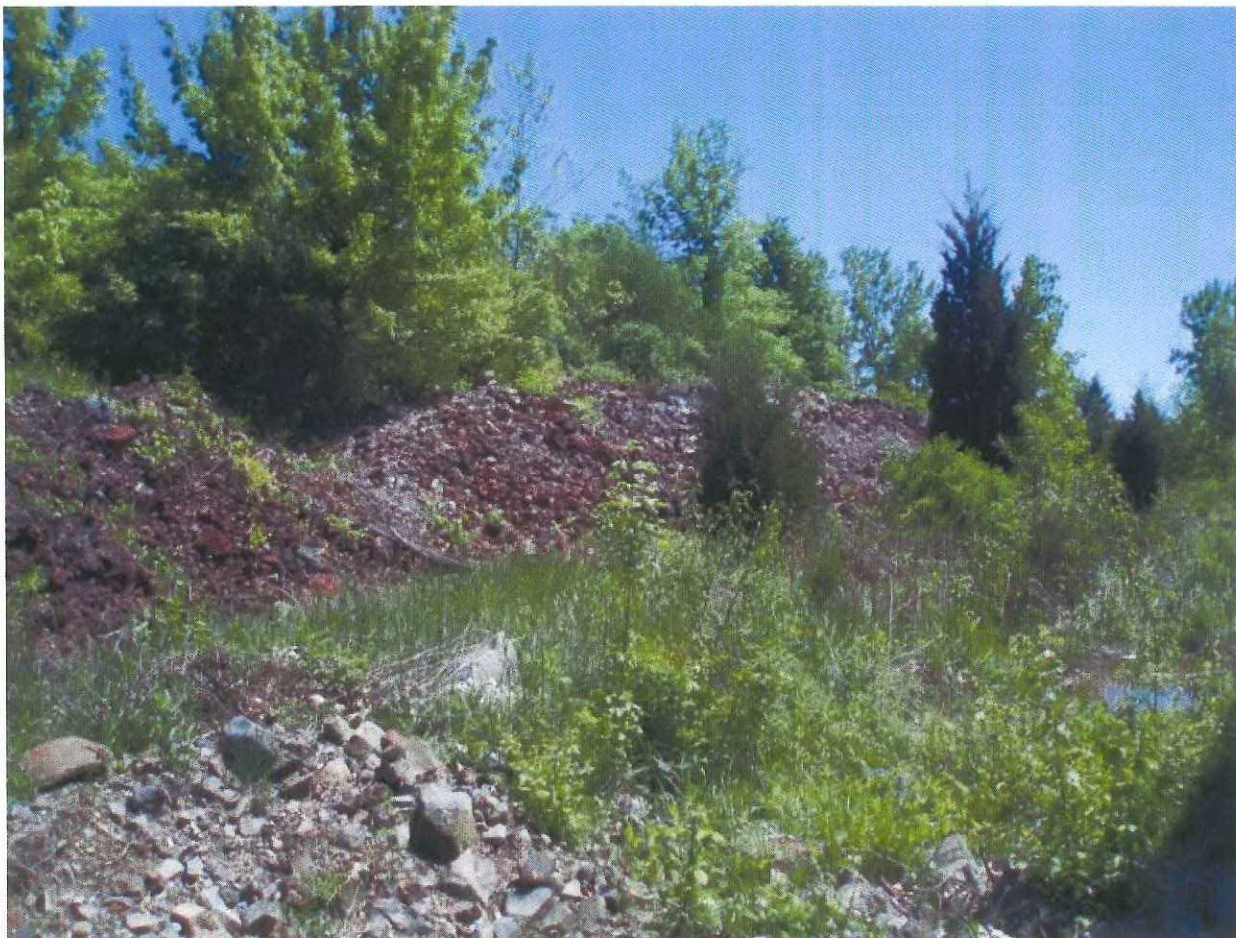
Photograph 4: Slag pile at Quemetco, Inc., Indianapolis, Indiana. The pile is located on the west side of Quemetco's property. The digital photograph was collected on May 18, 2009, at approximately 1:54 P.M. (CST). The photographer was Todd Brown, U.S. EPA. The filename is P5180004.

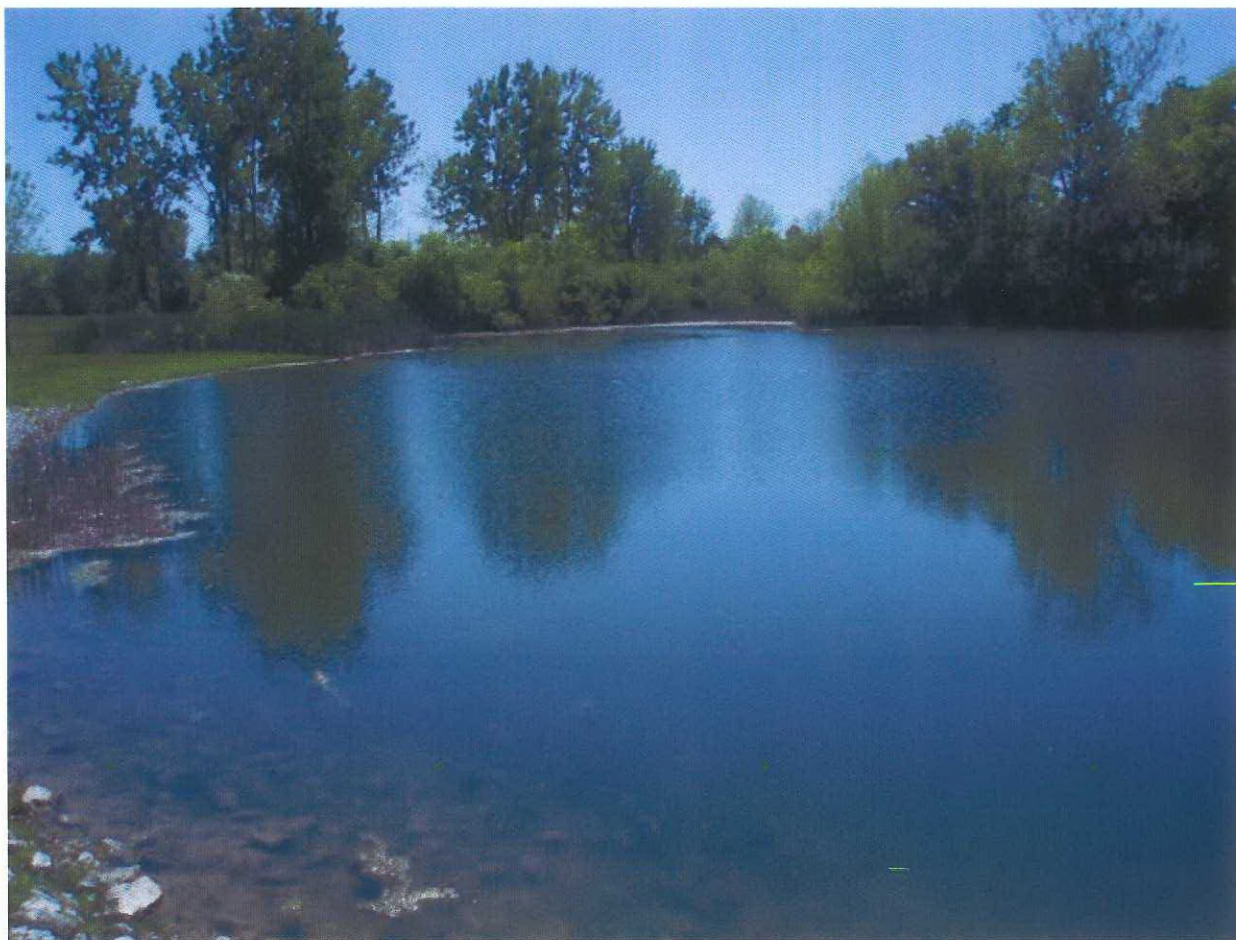
Photograph 5: Pond #3 at Quemetco, Inc., Indianapolis, Indiana. The digital photograph was collected on May 18, 2009, at approximately 2:01 P.M. (CST). The photographer was Todd Brown, U.S. EPA. The filename is P5180005.

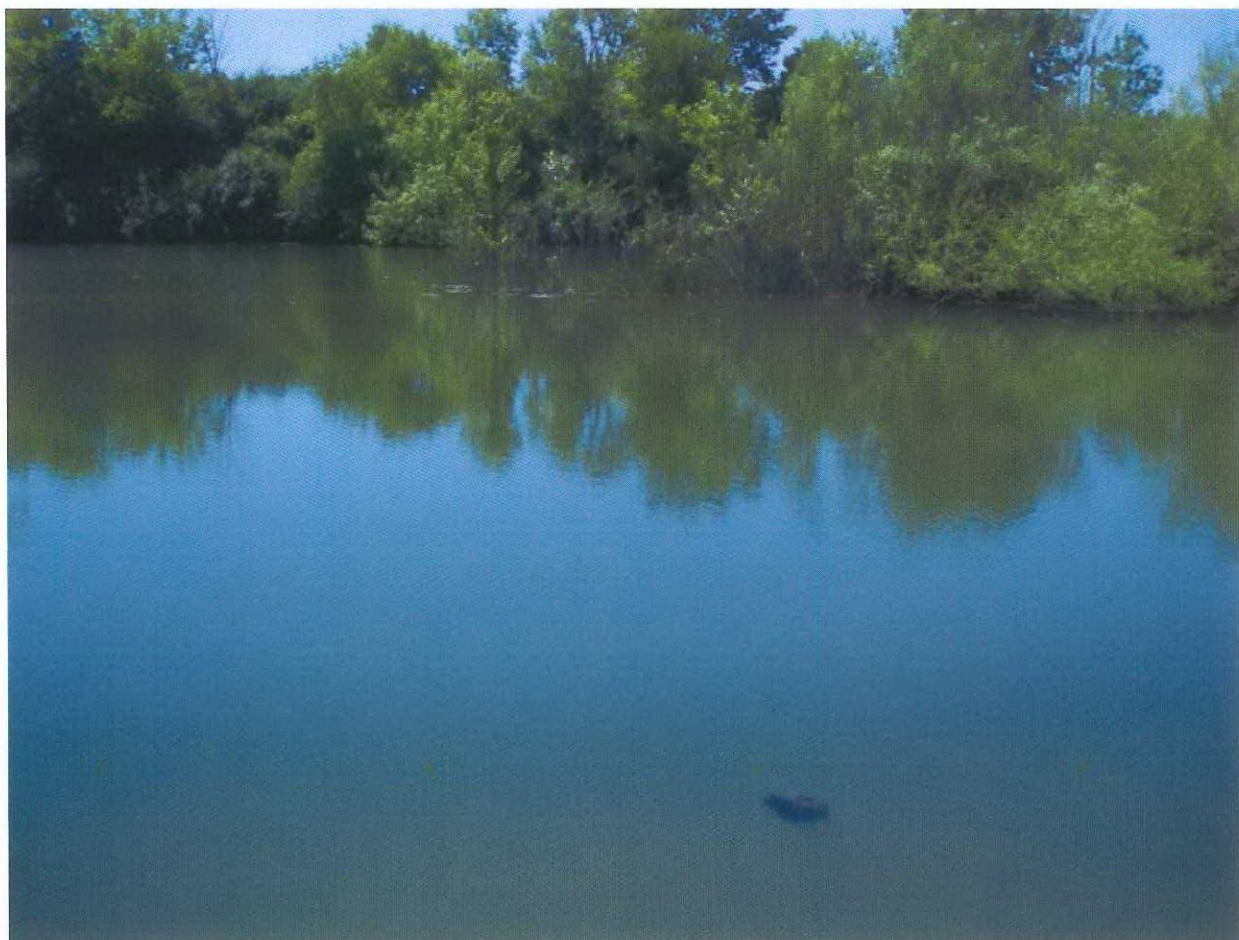
Photograph 6: Pond #3 at Quemetco, Inc., Indianapolis, Indiana. The digital photograph was collected on May 18, 2009, at approximately 2:01 P.M. (CST). The photographer was Todd Brown, U.S. EPA. The filename is P5180006.

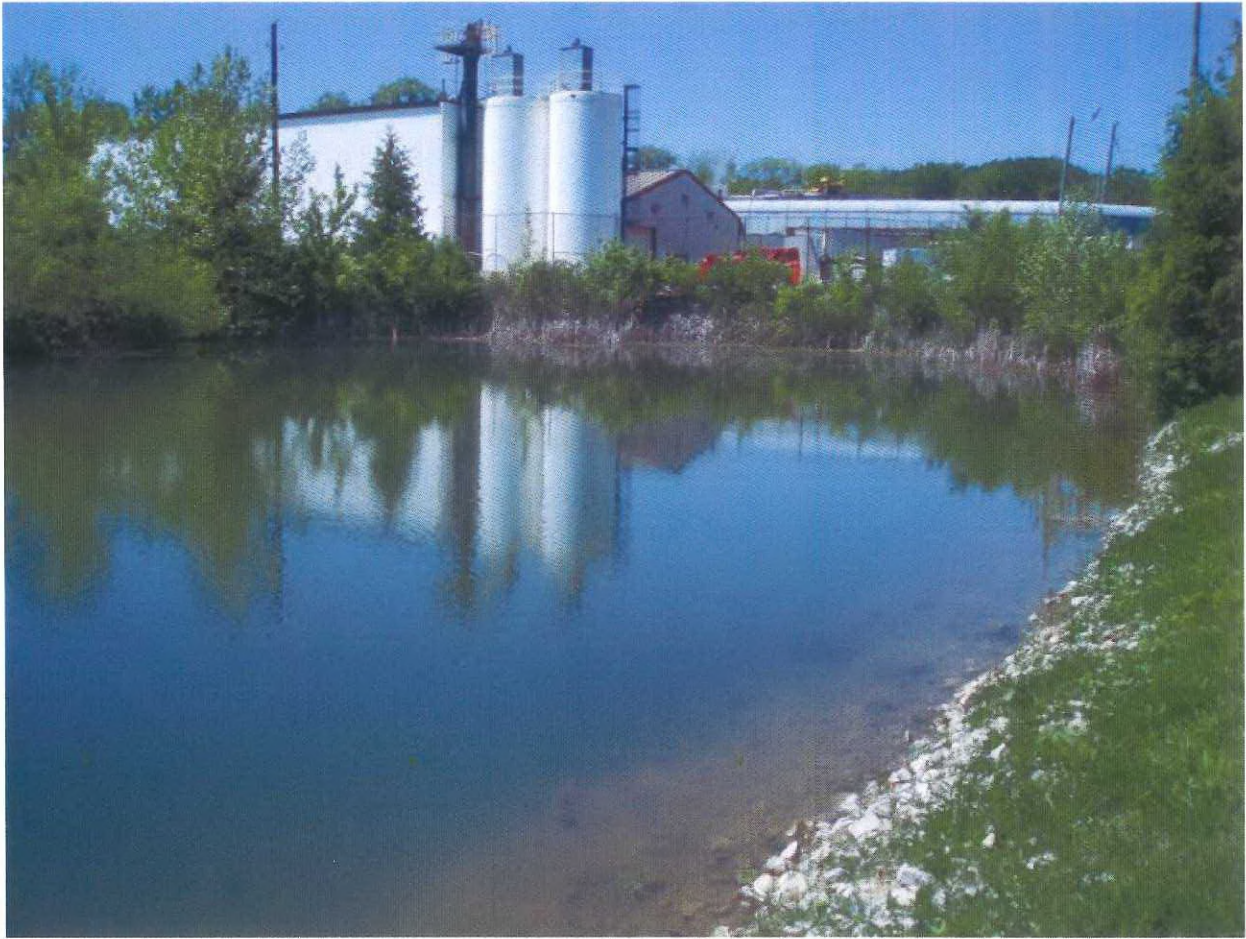
Photograph 7: Pond #3 at Quemetco, Inc., Indianapolis, Indiana. The Quemetco Plant is located in the background. The digital photograph was collected on May 18, 2009, at approximately 2:01 P.M. (CST). The photographer was Todd Brown, U.S. EPA. The filename is P5180007.

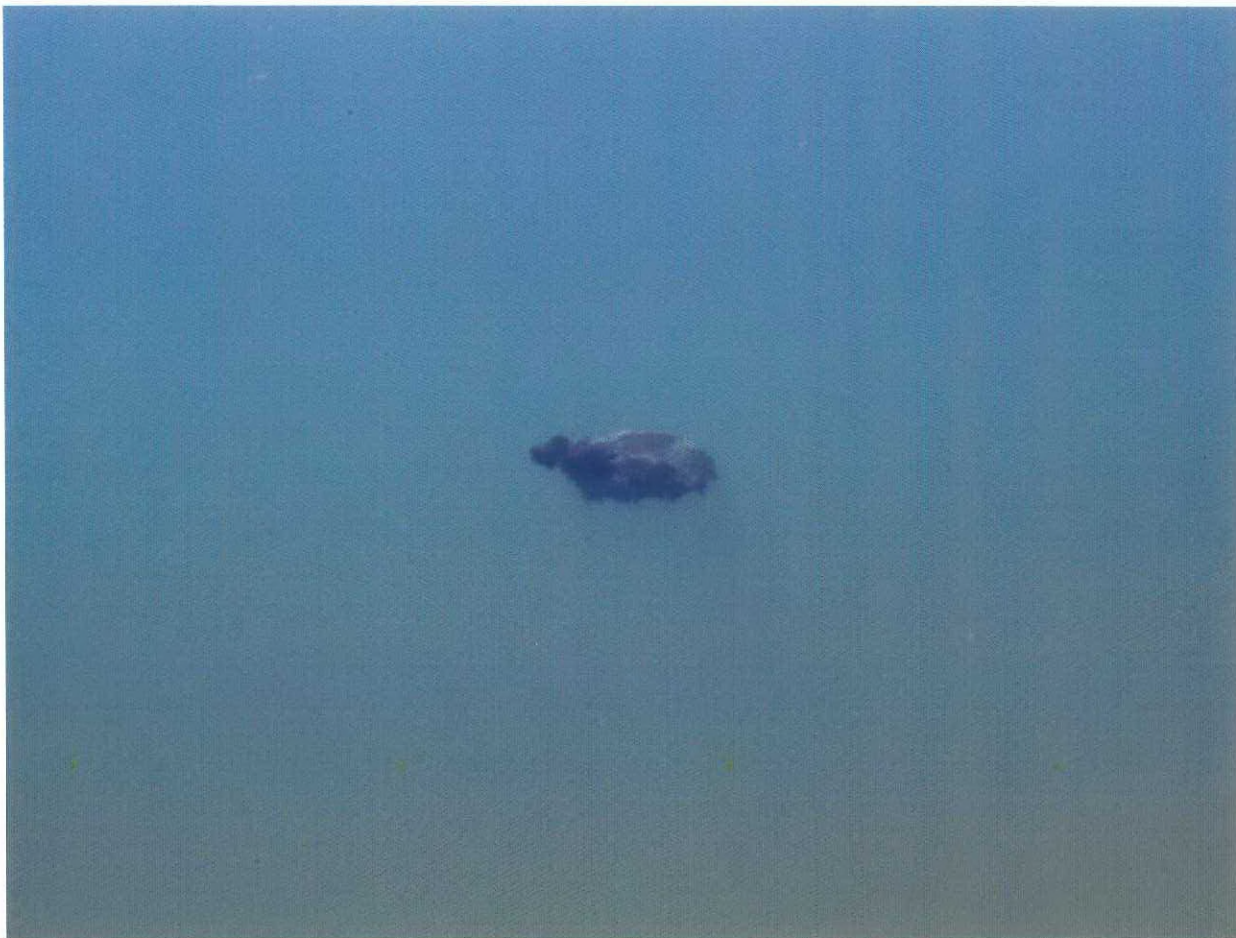
Photograph 8: Material floating in Pond #3 at Quemetco, Inc., Indianapolis, Indiana. The digital photograph was collected on May 18, 2009, at approximately 2:02 P.M. (CST). The photographer was Todd Brown, U.S. EPA. The filename is P5180008.

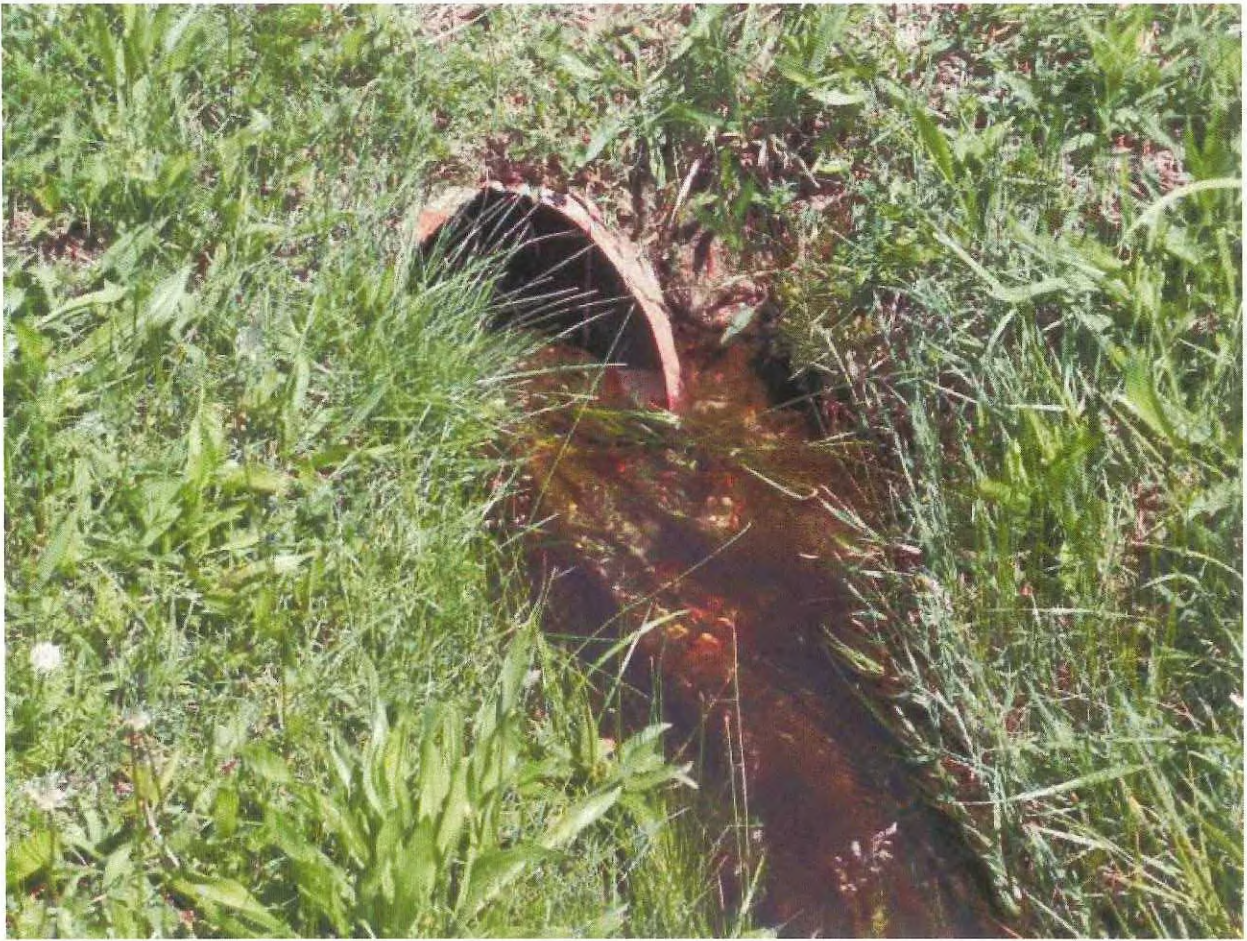
Photograph 9: Discharge pipe from Pond #3 to Julia Creek, at Quemetco, Inc., Indianapolis, Indiana. The digital photograph was collected on May 18, 2009, at approximately 2:06 P.M. (CST). The photographer was Todd Brown, U.S. EPA. The filename is P5180009.

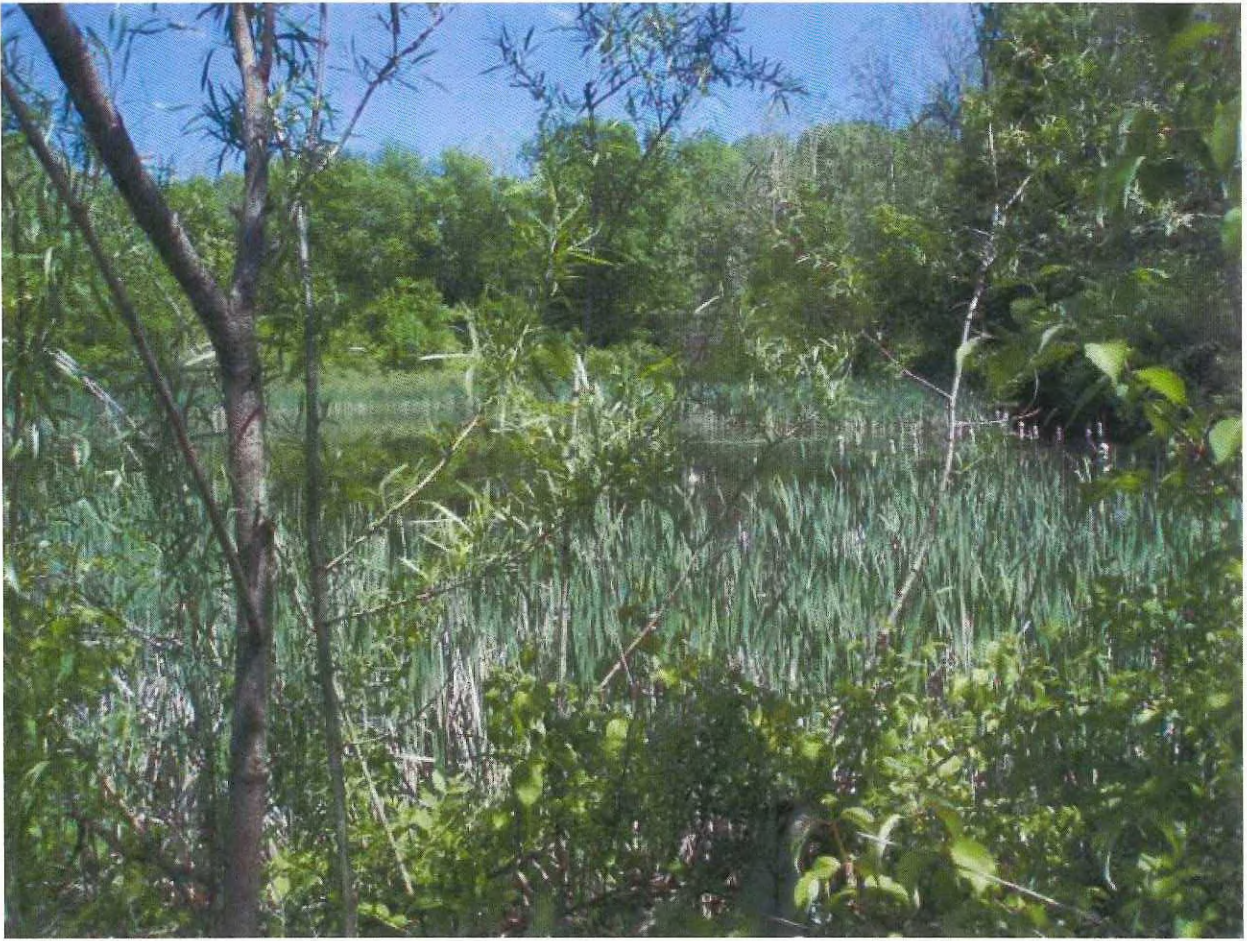
Photograph 10: Pond #2 at Quemetco, Inc., Indianapolis, Indiana. The digital photograph was collected on May 18, 2009, at approximately 2:07 P.M. (CST). The photographer was Todd Brown, U.S. EPA. The filename is P5180010.

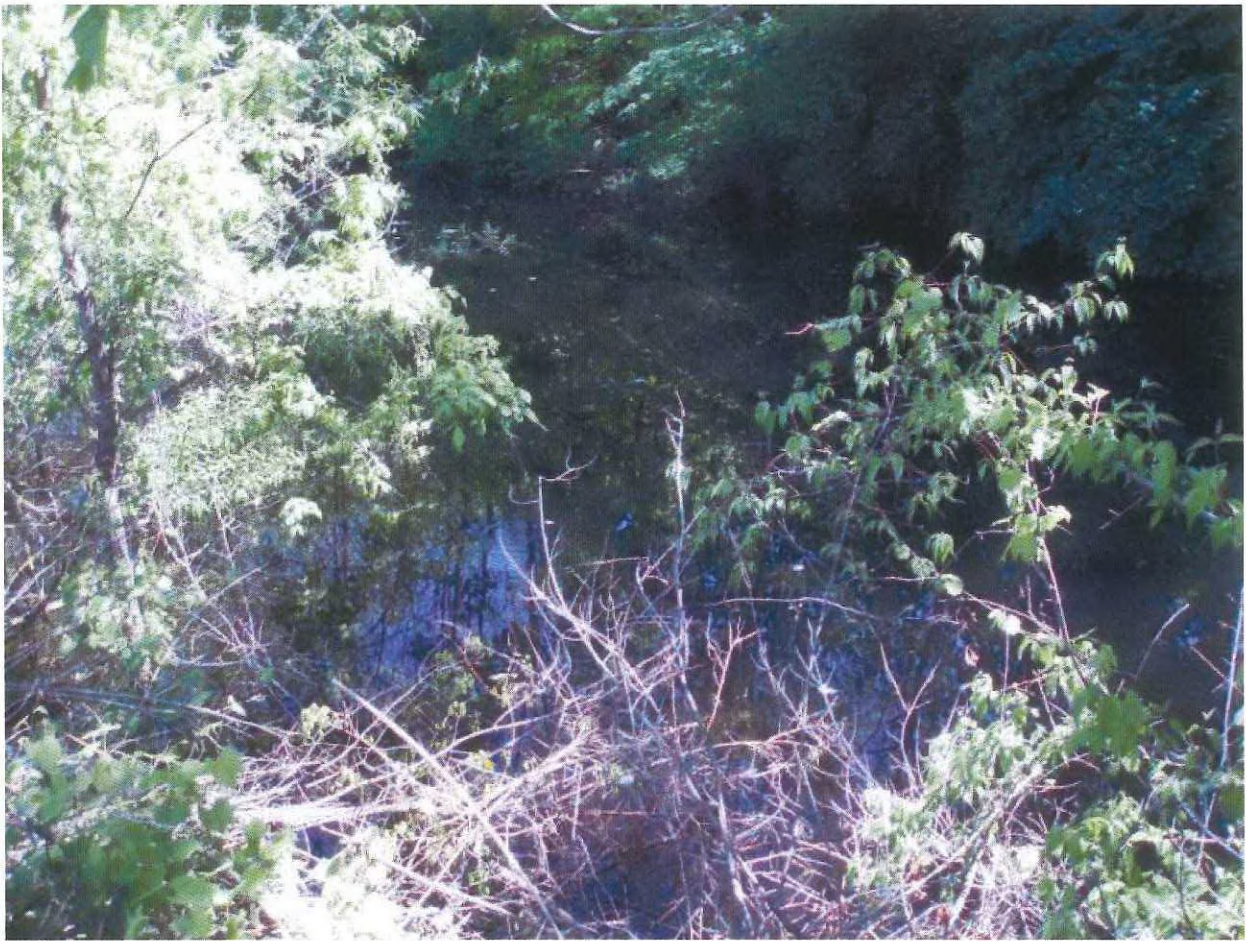
Photograph 11: Pond #1 at Quemetco, Inc., Indianapolis, Indiana. The digital photograph was collected on May 18, 2009, at approximately 2:10 P.M. (CST). The photographer was Todd Brown, U.S. EPA. The filename is P5180011.

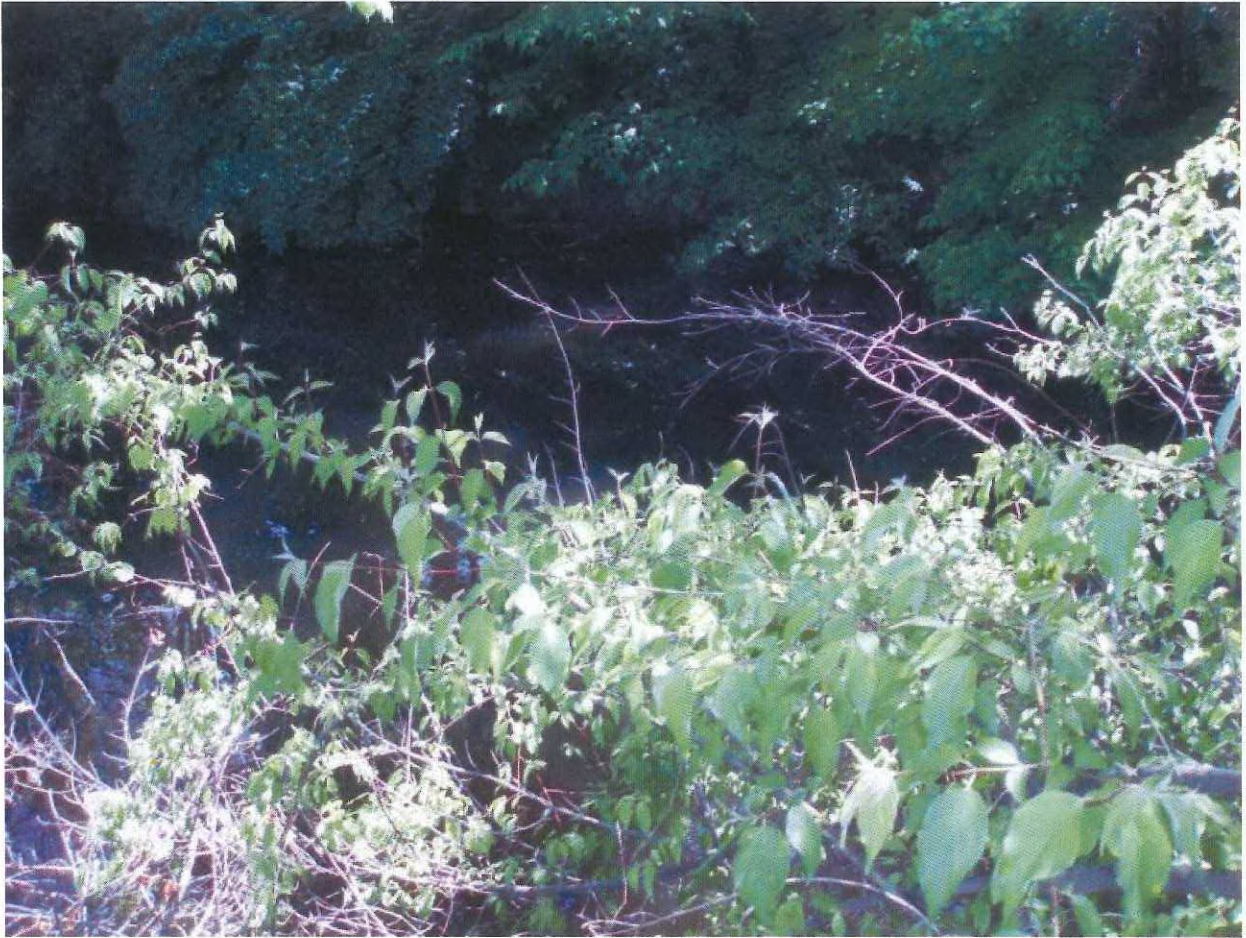
Photograph 12: Pond #1 at Quemetco, Inc., Indianapolis, Indiana. The digital photograph was collected on May 18, 2009, at approximately 2:11 P.M. (CST). The photographer was Todd Brown, U.S. EPA. The filename is P5180012.

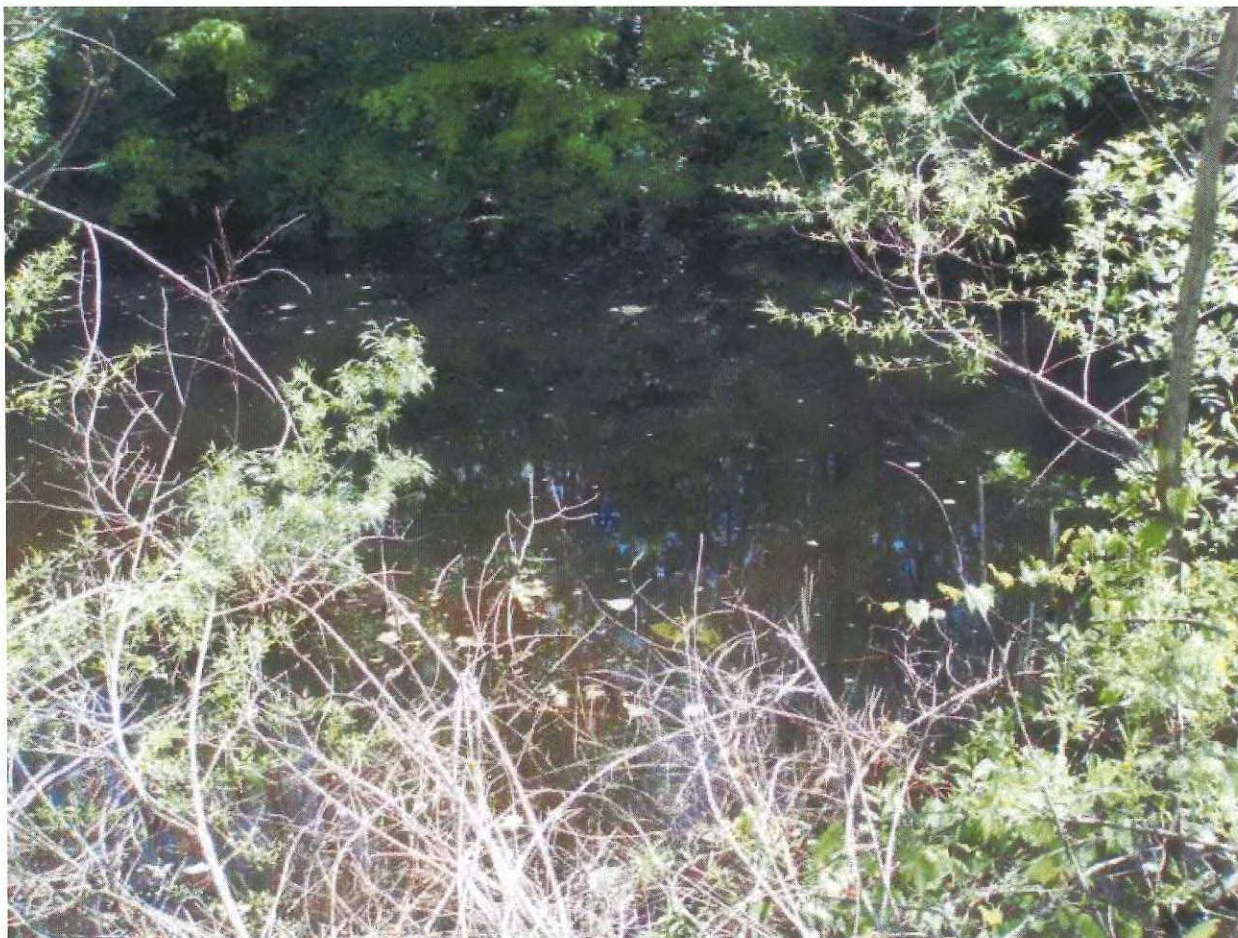
Photograph 13: Pond #1 at Quemetco, Inc., Indianapolis, Indiana. The digital photograph was collected on May 18, 2009, at approximately 2:12 P.M. (CST). The photographer was Todd Brown, U.S. EPA. The filename is P5180013.

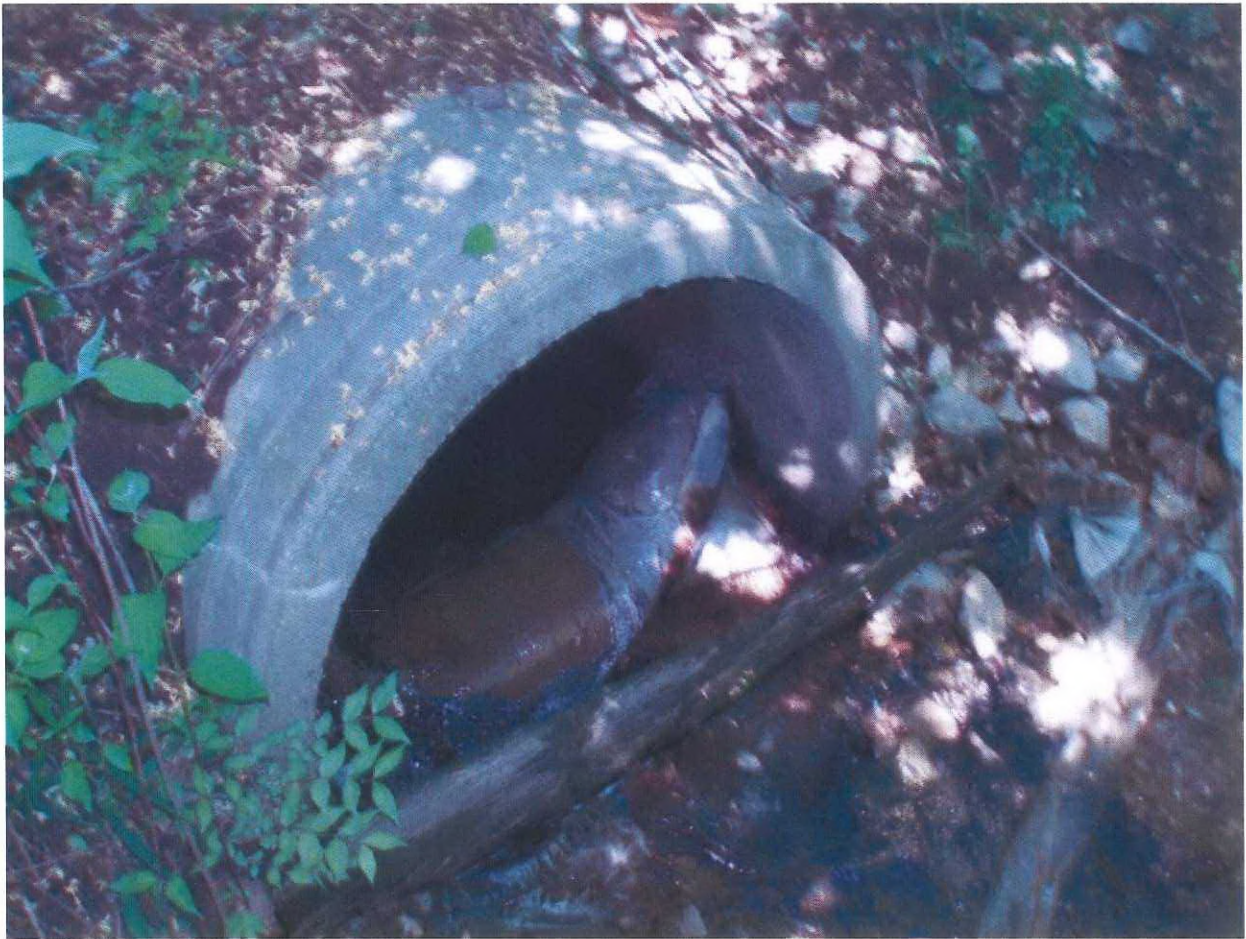
Photograph 14: Outfall from Pond #3 into Julia Creek at Quemetco, Inc., Indianapolis, Indiana. The digital photograph was collected on May 18, 2009, at approximately 2:18 P.M (CST). The photographer was Todd Brown, U.S. EPA. The filename is P5180014.

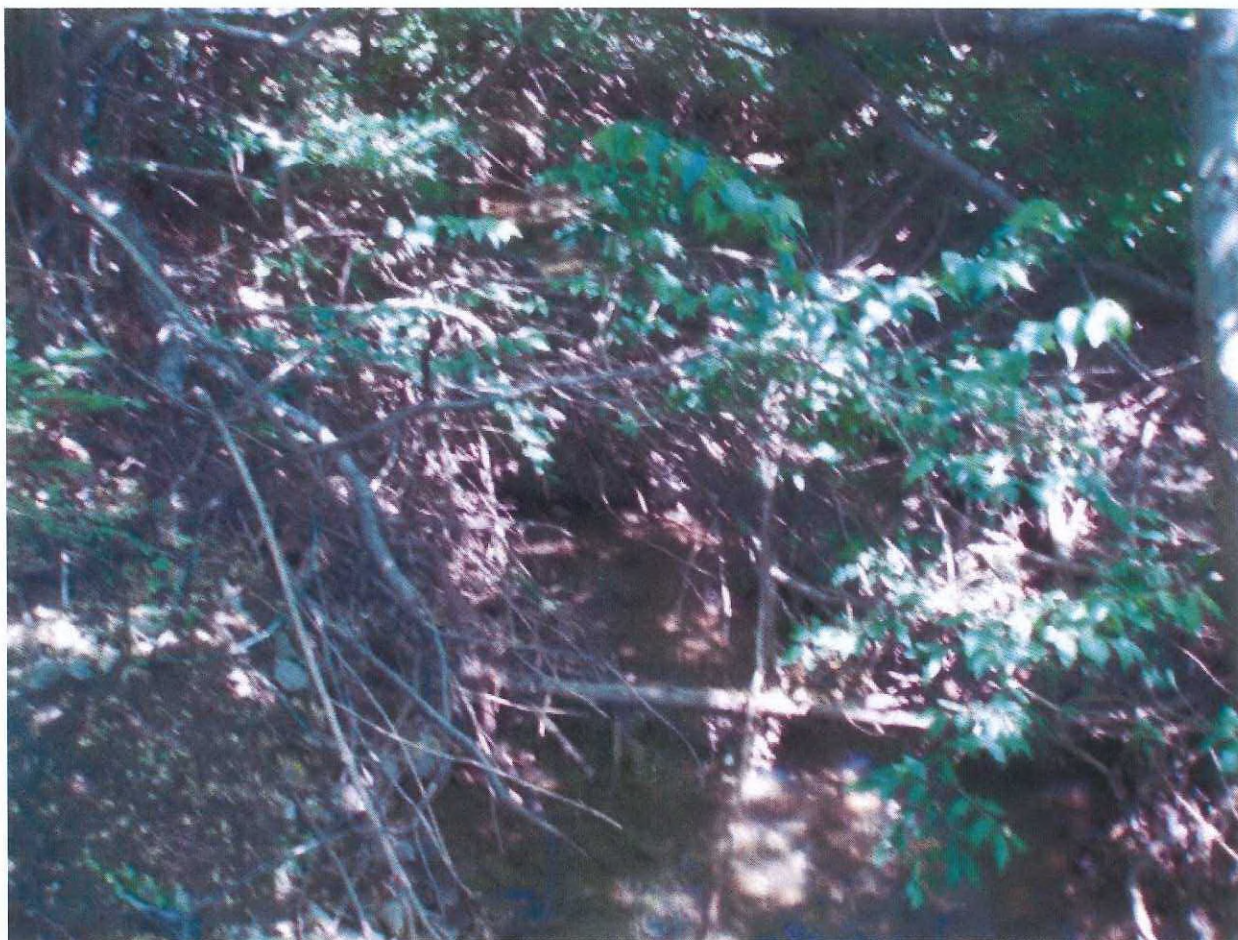
Photograph 15: Julia Creek at Quemetco, Inc., Indianapolis, Indiana. The digital photograph was collected on May 18, 2009, at approximately 2:19 P.M (CST). The photographer was Todd Brown, U.S. EPA. The filename is P5180015.

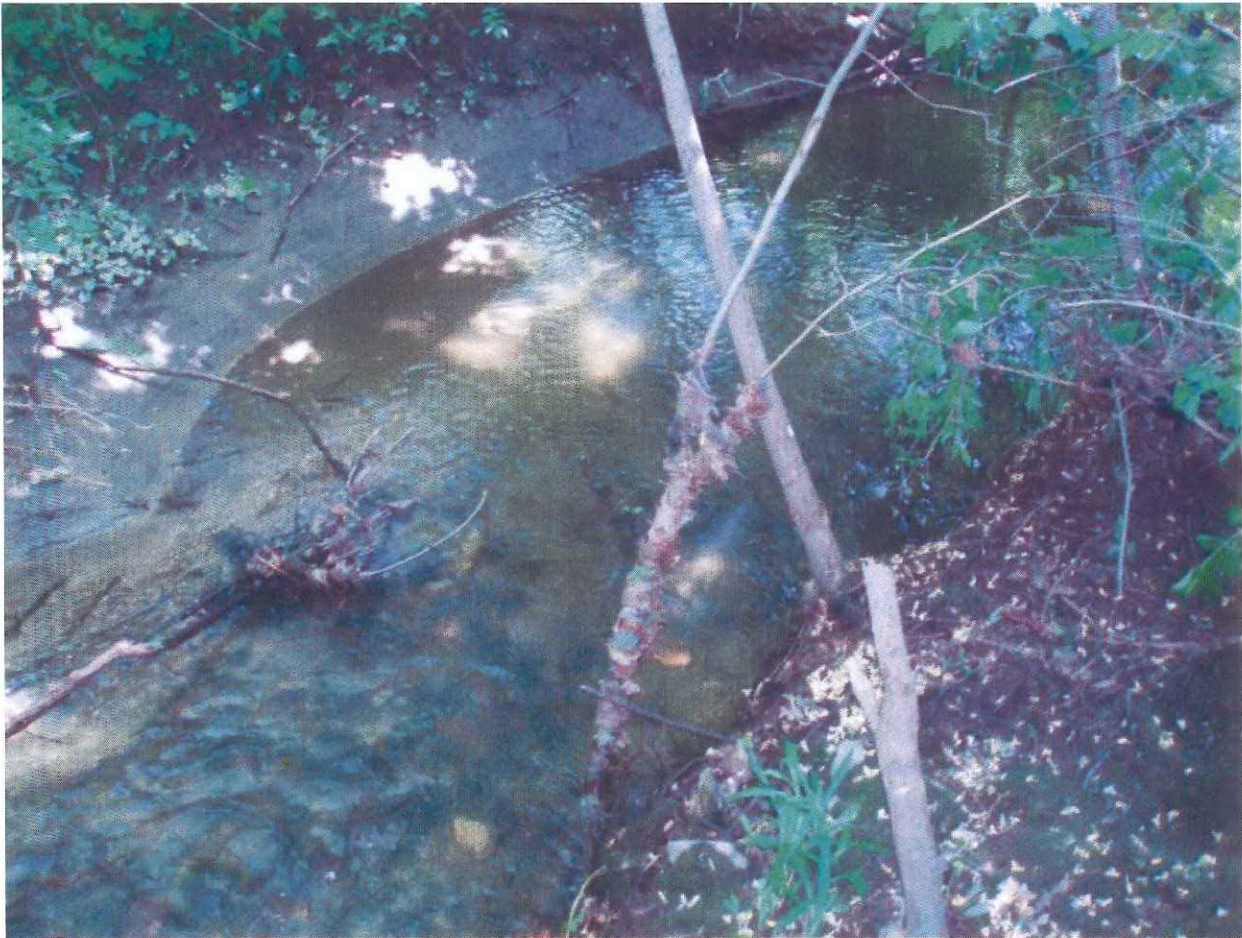
Photograph 16: Julia Creek at Quemetco, Inc., Indianapolis, Indiana. The digital photograph was collected on May 18, 2009, at approximately 2:19 P.M (CST). The photographer was Todd Brown, U.S. EPA. The filename is P5180016.

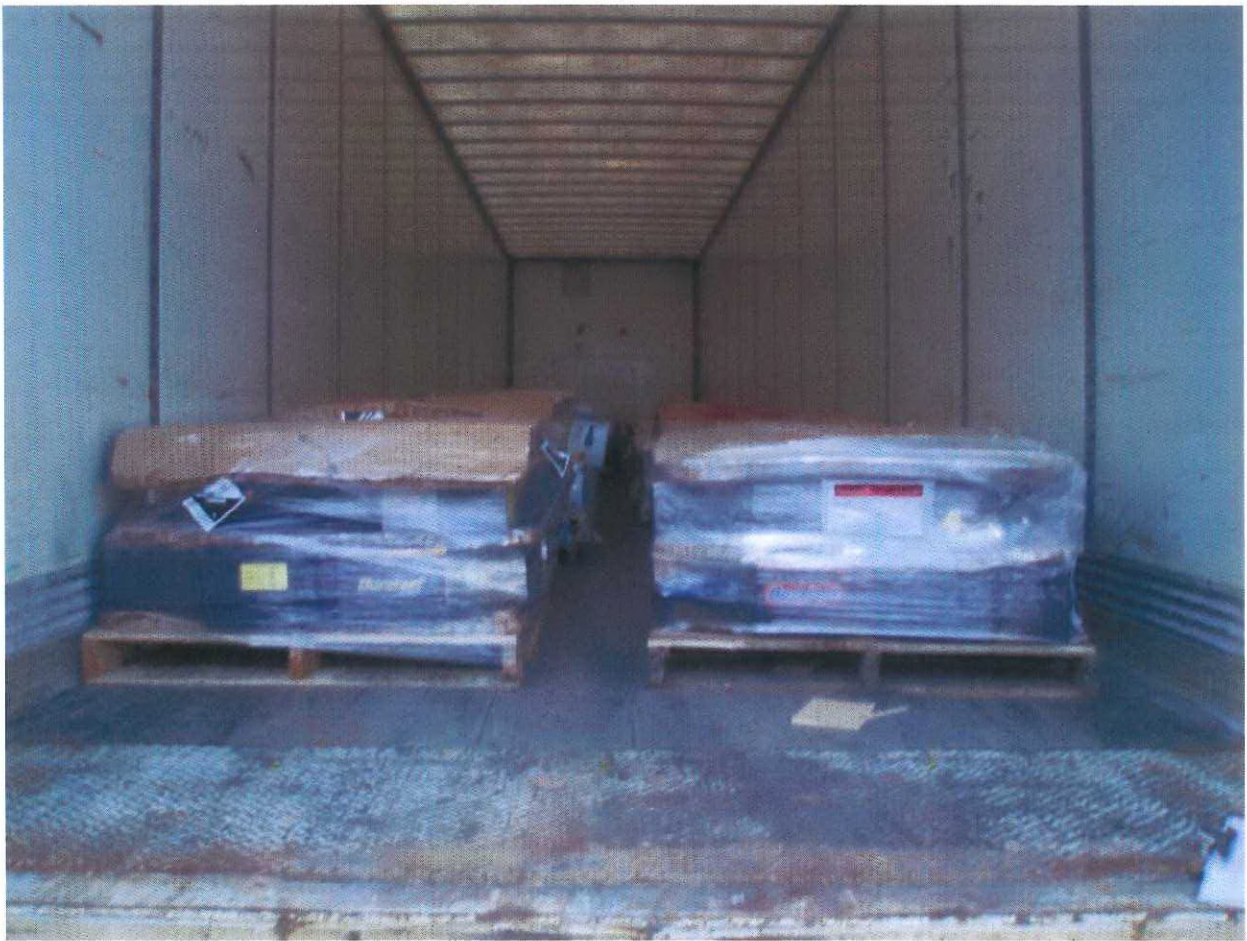
The tour began in a Receiving Area, outside of the Wrecker Dock, located on the southeast side of the Recycling Plant. I noted 12 trailers parked in this area. Photograph 17 features the contents of one trailer.

Photograph 17: Trailer of batteries at the Receiving Lot outside of the Wrecker Dock at Quemetco, Inc., Indianapolis, Indiana. The digital photograph was collected on May 19, 2009, at approximately 8:23 A.M. (CST). The photographer was Todd Brown, U.S. EPA. The filename is P5190017.

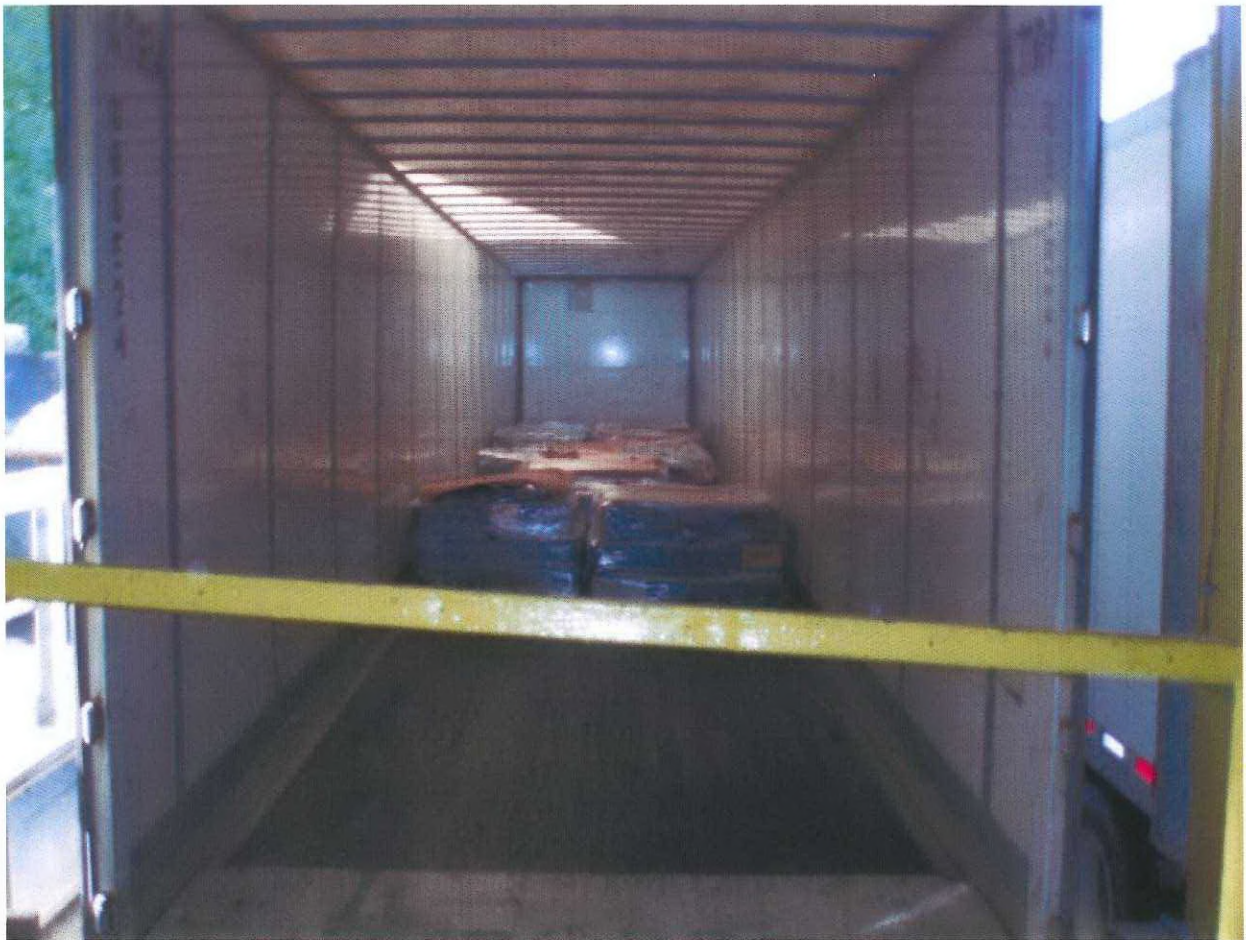
Photograph 18: Trailer of batteries being unloading at the Wrecker Dock at Quemetco, Inc., Indianapolis, Indiana. The digital photograph was collected on May 19, 2009, at approximately 8:27 A.M. (CST). The photographer was Todd Brown, U.S. EPA. The filename is P5190018.
